CAMDEN HAVEN RIVER ESTUARINE SHORELINE HABITAT CONDITION REPORT CARD 2023

Author: Jock Mackenzie
Earthwatch Institute

Survey Date: 15th August 2023.

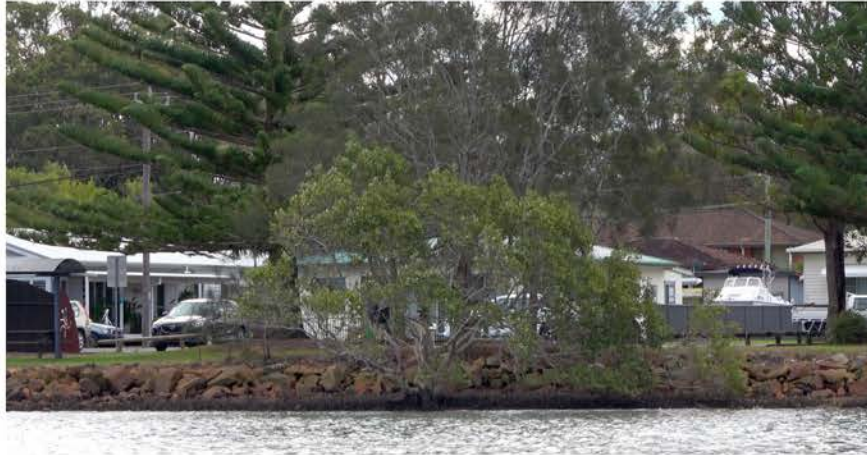
Mangrove cover along the lower Camden Haven River estuary is 'Moderate' compared to other surveyed estuaries. There are no mangroves present in the lower 1km of the estuary at the mouth with very low cover 3km upstream of the estuary mouth. Shoreline mangrove cover is highest at the confluence of the Camden Haven River and Stingray Creek. Extensive shoreline modification throughout the estuary, combined with increased estuary flow rates associated with hydrodynamic modification reduces mangrove establishment potential.

The absence of mangroves in the lower estuary limits natural climate risk mitigation, natural water quality improvement, fish habitat complexity and biodiversity refugia provided by shoreline mangroves. With increasing sea level rise and coastal hazard risks associated with climate change it is important that shoreline mangrove cover is improved in the lower estuary. To improve shoreline mangrove cover and associated ecosystem service values, it will be necessary to adopt ecological engineering approaches, such as living shoreline construction.

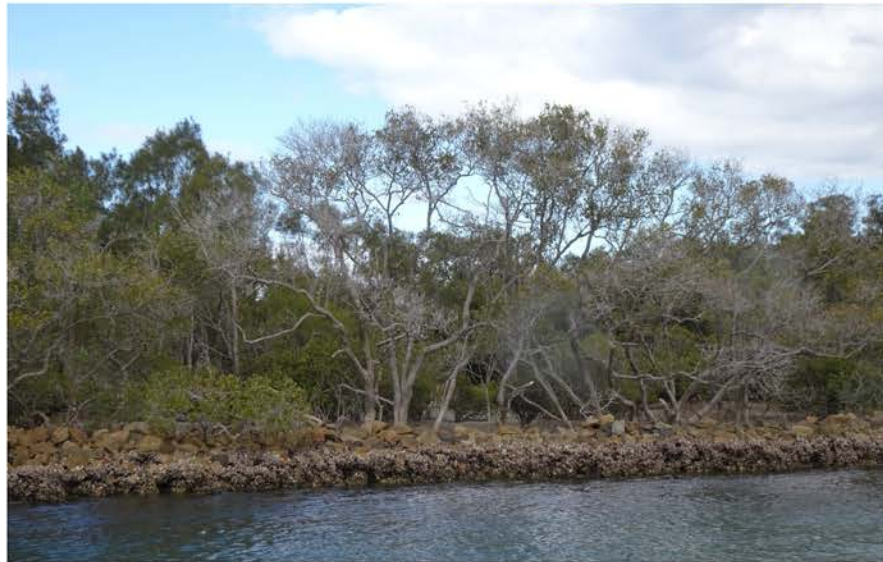
Mangrove condition along the Camden Haven River estuary is moderate, indicating that the majority of mangrove stands have minor dieback present, with many stands experiencing more severe dieback. Healthy mangrove stands (score 4-5) represent 42% of mangroves. An additional 35% had moderate dieback present. Mangrove stands in poor or very poor condition represented 22% of mangroves assessed, equivalent to 3.2km of mangrove shoreline. The relatively high proportion of poor condition mangroves suggests the presence of an ongoing or recent stressor impacting mangroves. Mangroves in the estuary were impacted by the 2019 bushfires, although this impact was largely restricted to the upper estuary in Watsons-Taylor Lake indicated by the moderate mangrove condition score for 11-12 km upstream. Based on this assessment, mangroves in the upper-mid estuary (5-7km upstream) and at the confluence of Stingray Creek had the lowest mangrove condition scores. Field inspection at the time of surveys show the cause of mangrove dieback and mortality in these estuary sections is linked to the 2021 flood event. This impact is described in more detail in the following report card section.

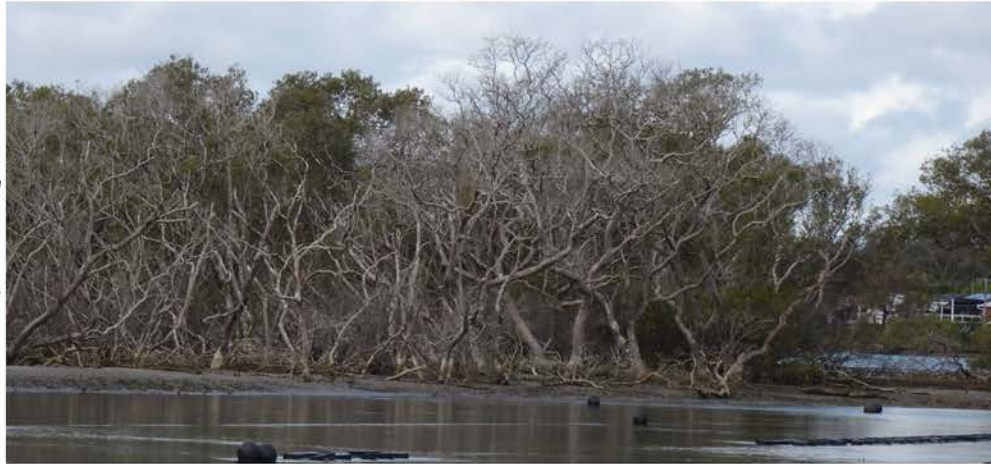
Recent severe flooding in NSW and Qld has significantly impacted fringing mangrove habitats. The Camden Haven River estuary experienced record flooding towards the end of March, 2021. The combination of the physical force of floodwaters, extended inundation period, sediment deposition on breathing roots, sediment erosion, impacts of prolonged freshwater on mangrove fauna and potential chemical pollutant deposition can result in extensive mangrove mortality. Often the effects of severe flooding do not become apparent until 6-12 months after flooding. Whilst mangroves can recover from flood events, full recovery from severe impacts can take 10-30 years. During the recovery period mangroves are vulnerable to additional climate and human pressures. Increasing sea levels often results in fringing mangrove setback leading to a nett loss of shoreline habitat. Within the Camden Haven River estuary, 31% of mangroves were severely impacted by flooding, with the most extensive impact in the mid-estuary. The primary driver of flood-related impacts appears to be sediment root burial. However, elevated nutrient loads may also increase flood impact risk.

This flood event highlights the vulnerability of shoreline mangroves to climate stressors. Given the recovery trajectory and likely loss of mangrove habitat, additional efforts to enhance and protect unimpacted mangroves should be considered.

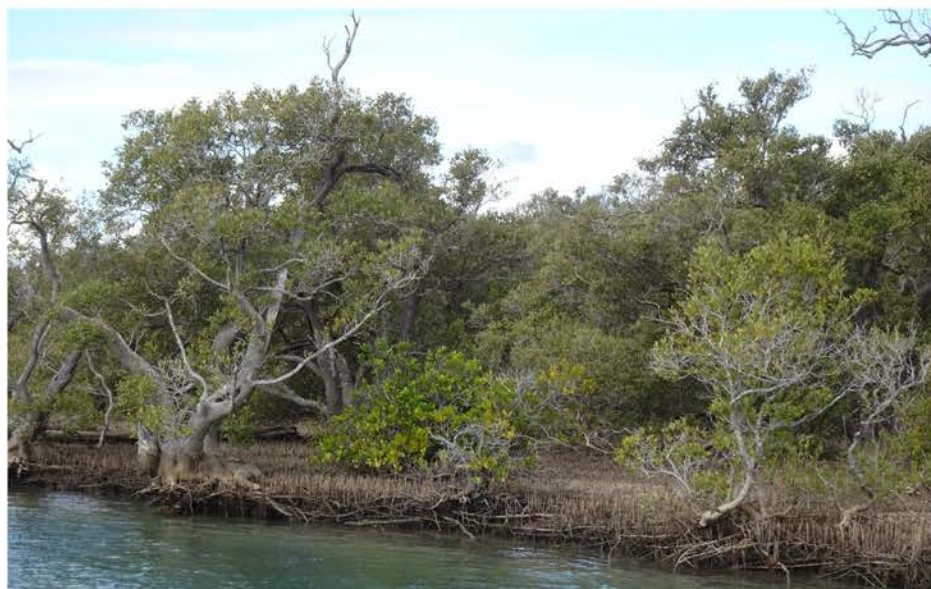
Erosion is the dominant shoreline physical process in the Camden Haven River estuary with 28% of the shoreline in an exposed and retreating state, however only 6% of erosion was classified as severe. Most erosion was recorded in the upper estuary. The extensive shoreline armoring along the lower estuary prevents natural shoreline dynamics that would normally be observed. The only erosion area of concern is an island at the confluence of Stingray Creek where high value habitat with very old Grey Mangroves (*Avicennia marina*) is at risk of loss from shoreline retreat.

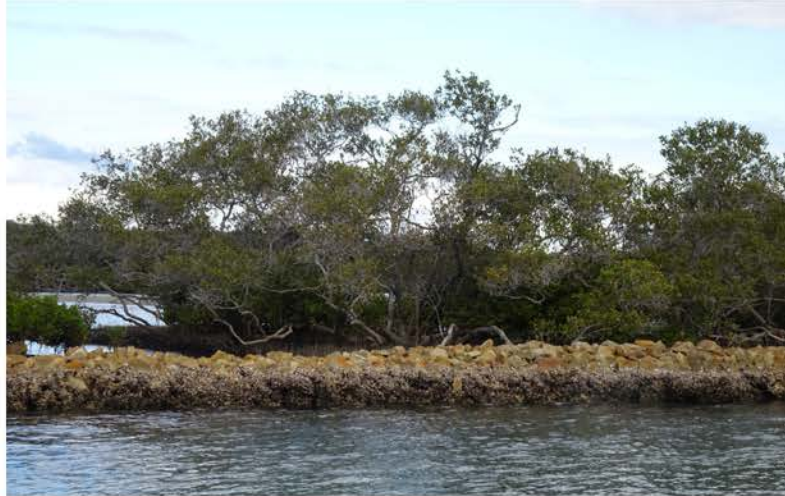
The majority of shoreline in the lower Camden Have River estuary is modified with rockwall and rip-rap structures. These modifications have substantially altered estuary hydrodynamics and increased tidal flow velocity in the lower estuary. High flow velocity limits mangrove rockwall colonisation and establishment potential. Consequently, there is low fish habitat diversity along the lower estuary main channel. In the mid estuary, mangroves are more frequently observed seaward of rock wall structures, highlighting the potential to integrate additional green-grey shoreline modification approaches within the estuary. Historically, bank hardening was not designed with mangrove habitat in mind. However, these existing structures can be modified to enhance mangrove colonisation to maximise both shoreline protection and stabilisation and habitat-related values including climate change risk reduction using a 'living shoreline' approach.

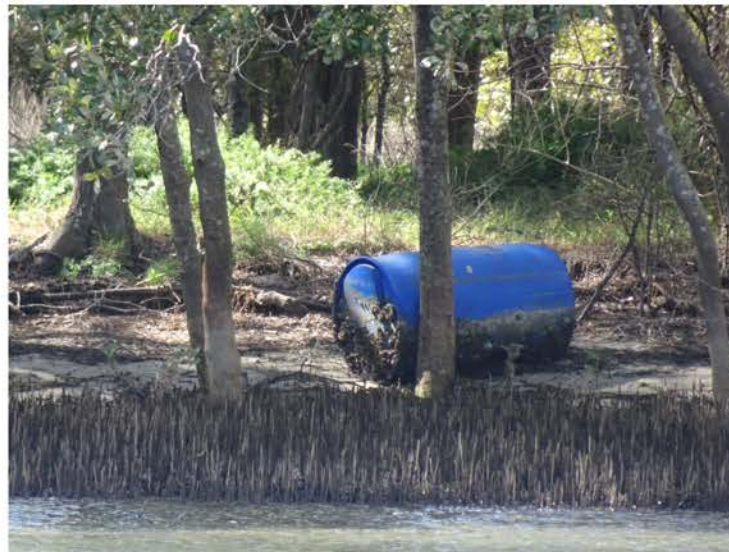
There were 49 items of marine debris along the surveyed shoreline, equivalent to 2.33 items per km of shorelines. Small litter items were mostly soft plastic packaging. Larger debris items were blue storage barrels associated with the oyster industry, other larger plastic items and dumped building rubble used for shoreline stabilisation. The breakdown of these items can lead to microplastic pollution and additional toxins entering the marine environment and marine food chain. Exposed geofabric along some rockwall sections. This material has been shown to be a significant source of microplastics. Plastic in the mangrove environment is likely to impact crabs and other mangrove macrobenthic fauna important for ecosystem health.

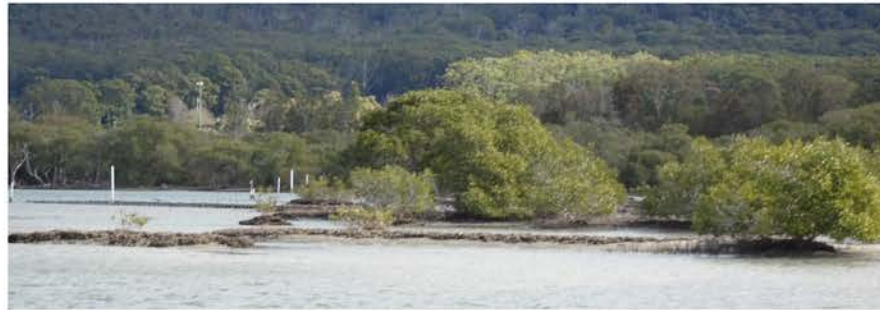
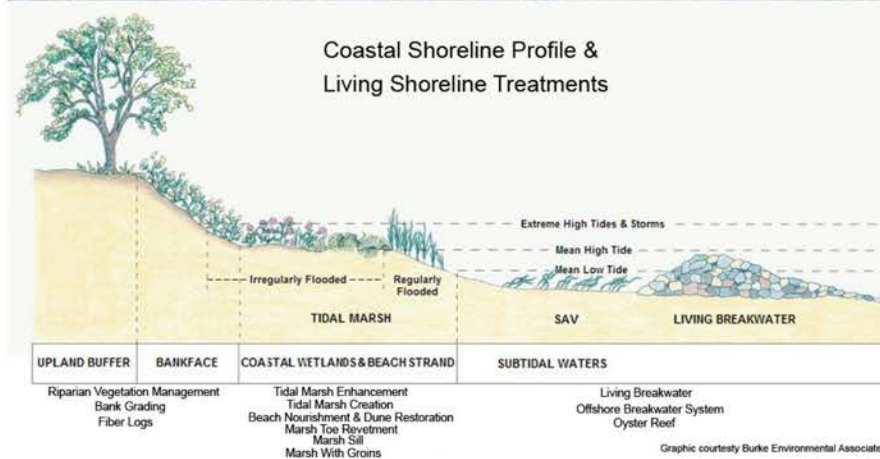
Mangroves in the mid-estuary near the confluence of Stingray Creek were severely impacted by the 2021 flood event and resulting sediment root burial and shoreline erosion. There is risk of significant and high-value habitat loss in the near future without intervention. Compounding climate change pressures increase the need for implementing active climate adaptation measures to protect mangrove habitat to ensure the long-term protection of estuary ecosystem values and reduce coastal hazard risks. These measures will require integrated engineering approaches. The business-as-usual conservation approach to estuary management is no longer appropriate. During S-VAM surveys it was observed that historically dumped oyster shells provided a living breakwater that protected adjacent mangroves from flood events. Similar observations have been made elsewhere. The opportunity to install additional living breakwaters using oyster shell as a means to protect mangrove habitat should be investigated. Living breakwater structures could be complimented by the construction of 'mangrove garden' living shorelines to assist in offsetting any additional habitat loss in the mid-estuary.
