CLYDE RIVER ESTUARINE SHORELINE HABITAT CONDITION REPORT CARD 2023

Author: Jock Mackenzie
Earthwatch Institute

Survey Date: 10th August 2023.

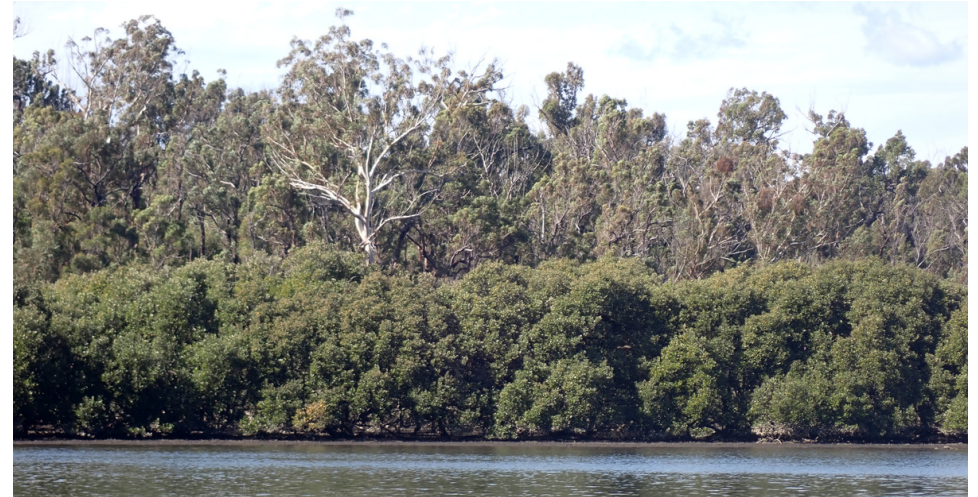
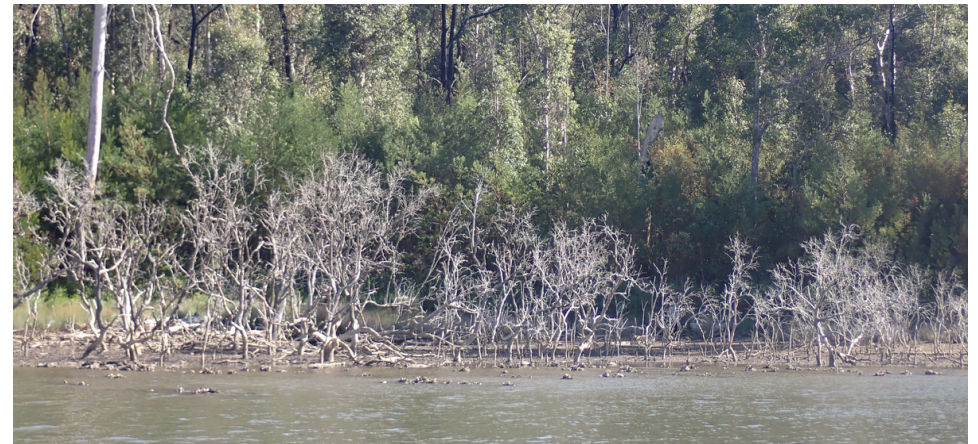
Mangrove condition along the Clyde River is overall 'moderate'. The majority (62%) of fringing shoreline mangroves were either in good to very good condition. A high proportion (15%) of mangroves were classified as 100% dead, resulting in the lower overall condition score.

Healthiest mangrove stands were in the lower-mid estuary 4-5km upstream and in the upper-mid estuary (8-9km upstream). Mangroves in poor and very poor condition were present 7-8km upstream and in Waterfall and Mundarlow Creeks.

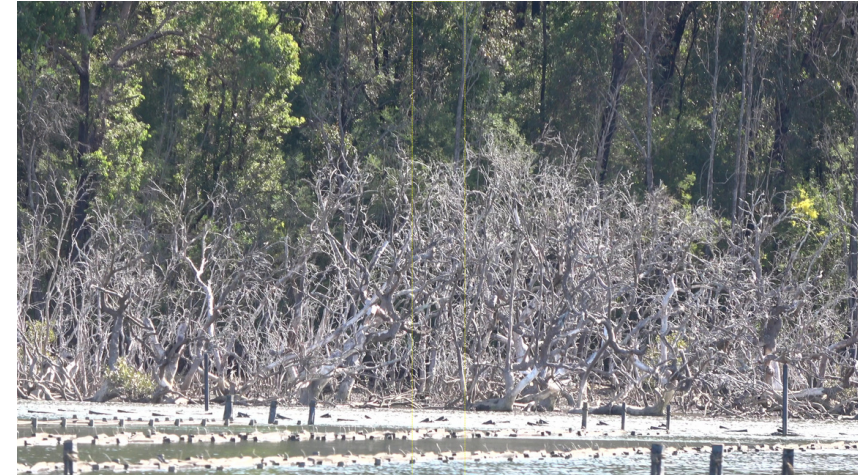
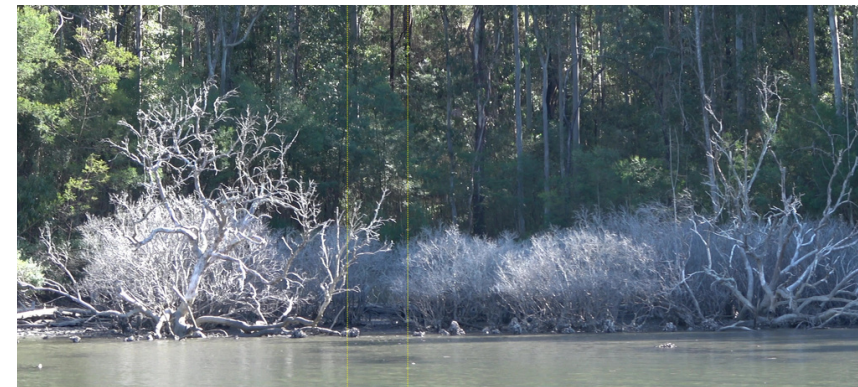
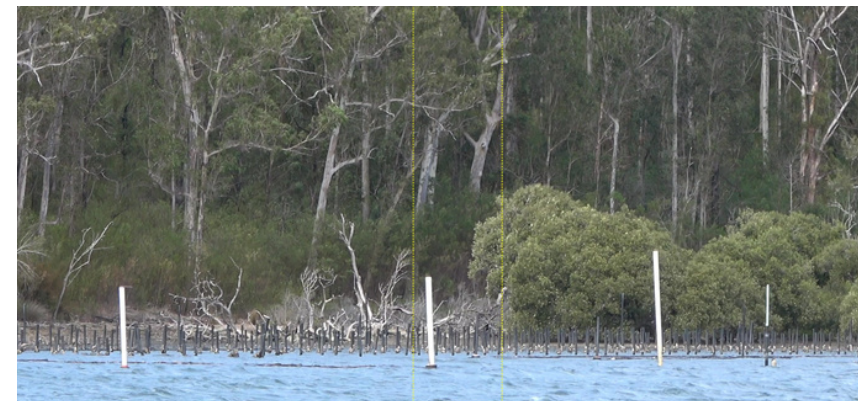
Proportion of mangrove habitat impacted by fire =
21% (2.7km shoreline habitat)

The 2019/2020 'Black Summer' bushfires significantly impacted mangrove habitats across 16 estuaries in NSW. This was the first recorded large-scale mangrove dieback event caused by fire. In the Clyde River, 5% (14.5 ha) of mapped mangroves were recorded as being impacted by fire. In the lower and mid Clyde River estuary, 21% of shoreline mangroves were documented as bushfire impacted. Mangroves impacted by fire had nearly 100% mortality. There was no evidence of transition zones between impacted and unimpacted mangroves.

Shoreline survey data suggests that fire had a greater impact on mangrove habitat in terms of linear shoreline habitat (21%) compared to assessments of total area (5%). Impacts to narrow fringing mangrove stands along estuary shorelines are important to consider as these stands have distinct characteristics and values that set them apart from the broader habitat areas including habitat continuity, fish habitat, sediment trapping and nutrient exchange and shoreline stability. The potential loss and degradation of 20% of fringing shoreline habitat in an otherwise healthy estuary should be cause for concern.

The 2019/2020 'black summer' bushfire is the primary driver of poor condition mangroves in the Clyde River

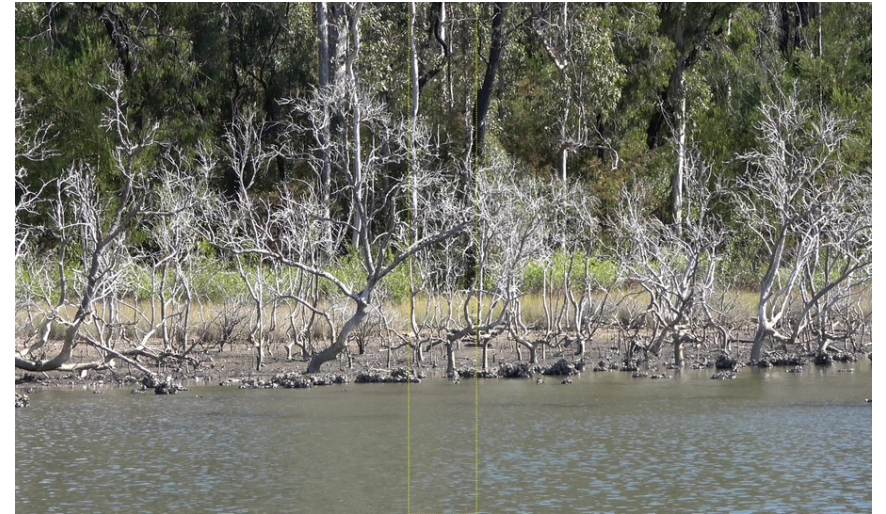
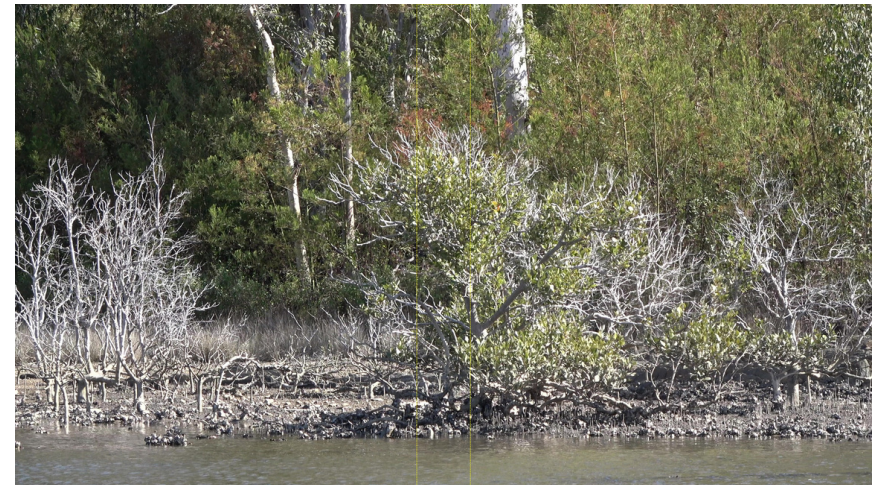
Proportion of mangrove habitat impacted by fire
in recovery/regrowth phase = 13%
(0.35km shoreline habitat)

Only 13% (350 m) of fire impacted shoreline mangroves were recorded as showing signs of recovery 3.5 years after the initial impact. Based on recovery trajectories of mangroves elsewhere following severe natural disturbance events (eg. Boyne River, Gladstone), it is possible that these mangroves may never recover.

Recent La-Nina driven high tide levels, combined with sea level rise, likely sediment surface elevation subsidence and erosion following tree death and biogeochemical changes in dead forests, may be impeding mangrove seedling establishment. The presence of dead wood movement in the tidal zone also has the potential to damage new recruitment and prevent recovery.

Based on evidence to date, natural recovery of fire impacted mangroves in the Clyde River appears unlikely to occur in the future.

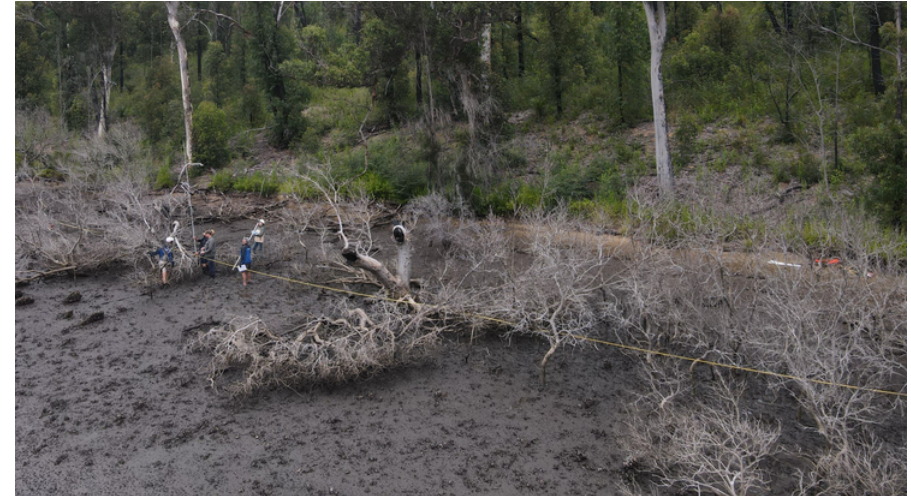
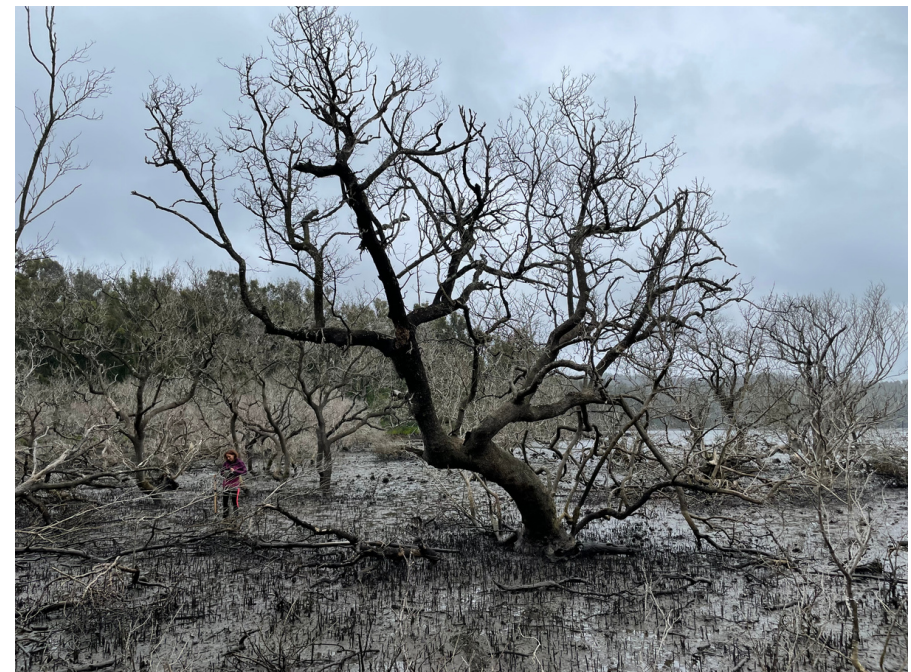
Live trees = 0.8% Dead trees = 99.2%

At the four mangrove transect locations impacted by fire, 99% of trees were dead irrespective of species and size. No seedling establishment was recorded along the transects indicating lack of recovery. Epicormic resprouting was observed on some Grey Mangrove (*Avicennia marina*) trees outside the transect bounds.

Based on the estimates of mangrove forest biomass derived from transect measures, if there is no recovery of fire affected mangroves it is estimated that the 2019/2020 'Black Summer' bushfire mangrove death in the Clyde River could result in the release of $\sim 8,900 \pm 4,300$ tonnes of CO₂, equivalent to the annual emissions of between 325 and 858 Australians. This figure does not include the lost carbon sequestration potential. The above figure is an estimate only to highlight the importance of intervention to prevent carbon emissions in addition to habitat loss prevention.

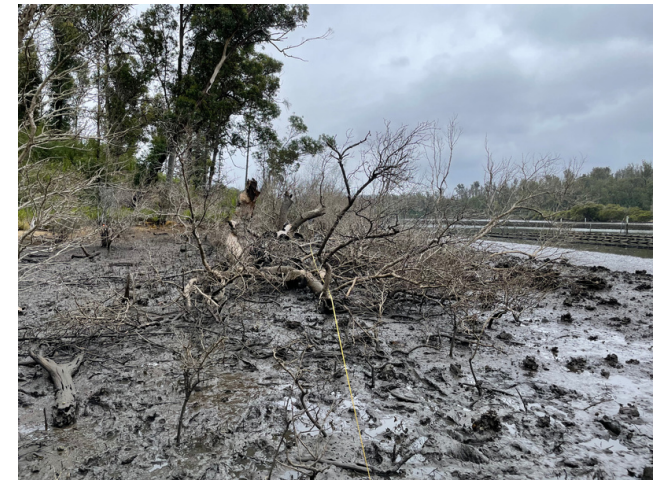
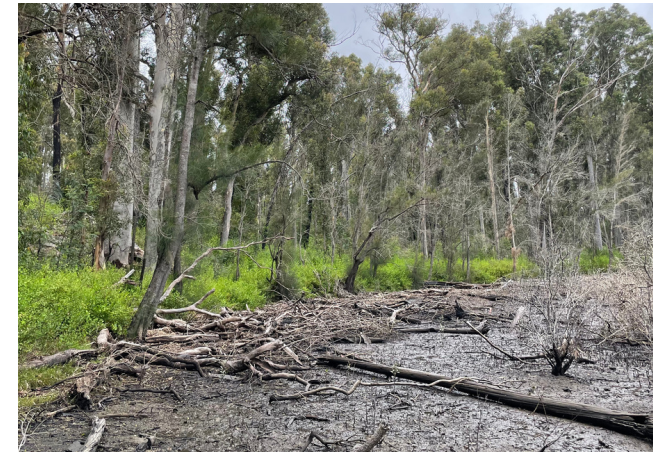
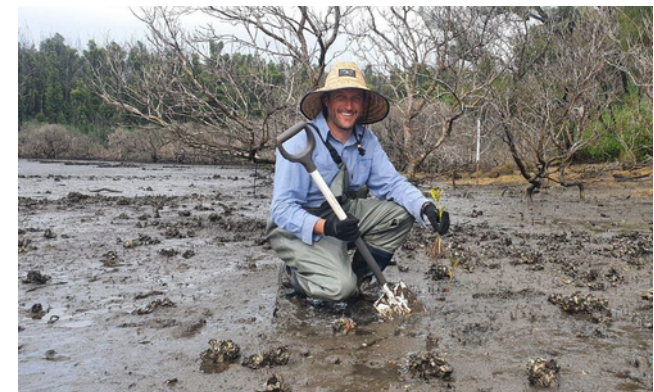
Without recovery in the near future, there is the possibility that 20% of shoreline mangrove habitat will be lost. As time progresses, recovery will become increasingly less likely as surface sediment continues to subside and erode, and sea levels rise. The loss of 20% (2.4km) of shoreline habitat will have implications for estuary biodiversity, fisheries production, water quality, carbon storage and the local oyster industry.

It is recommended that intervention is undertaken to assist mangrove recovery in the Clyde River estuary. Based on the findings from this assessment, there is minimal natural post-fire recovery occurring at the estuary scale. Recent direct planting efforts in impacted mangroves have also been mostly unsuccessful. Field observation indicate that limited natural seedling establishment is occurring at the high intertidal margins, indicating that a surface elevation deficit and increased tide levels may be preventing seedling establishment lower down the tidal profile.

The oncoming El-Nino climate event presents a window of opportunity to undertake broadscale assisted mangrove rehabilitation. During the oncoming El-Nino period tidal amplitude will be dampened and there is a reduced risk of riverine flooding creating suitable conditions for mangrove establishment and growth. The installation of temporary or permanent structures to trap sediment and increase surface elevation, whilst minimising wave action, will be necessary to facilitate natural recruitment. Without such intervention there is a high probability of continued recovery failure. Additional physical removal or processing of woody debris in impacted areas should also be considered to prevent physical damage to mangrove seedlings.

Intervention should occur quickly and simultaneously with ongoing research into the long-term effects of mangrove dieback.
