CAMDEN HAVEN RIVER ESTUARINE SHORELINE HABITAT CONDITION REPORT CARD 2023

Author: Jock Mackenzie
Earthwatch Institute

Survey Date: 15th August 2023.

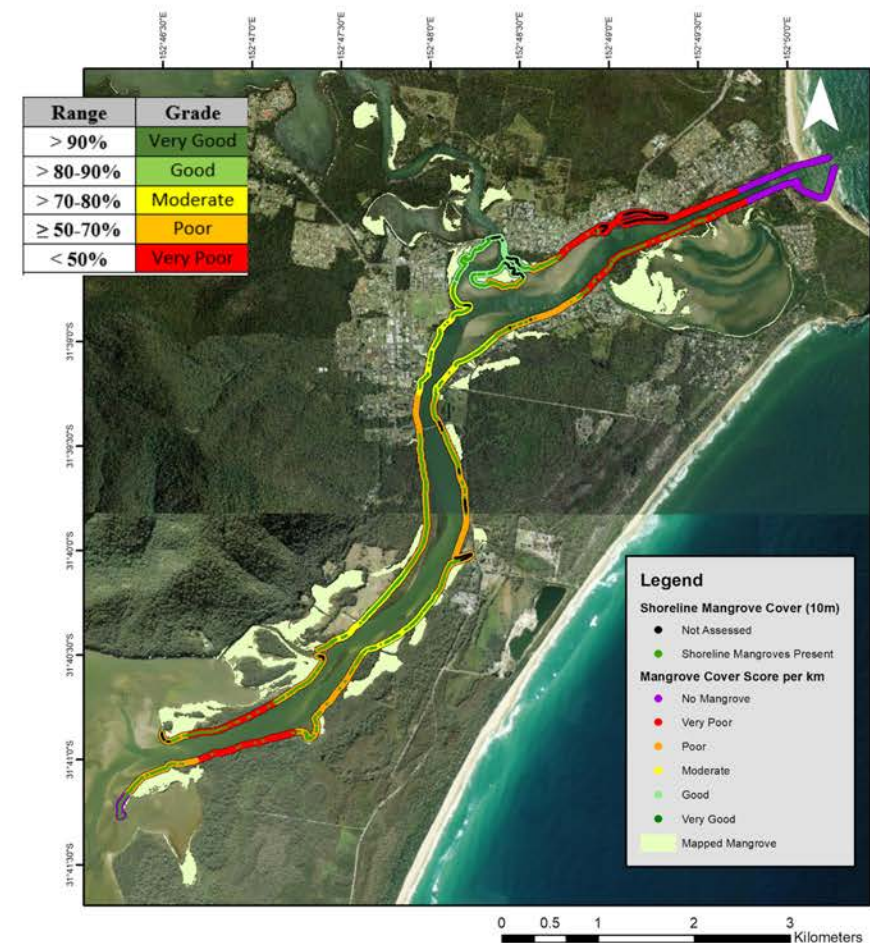
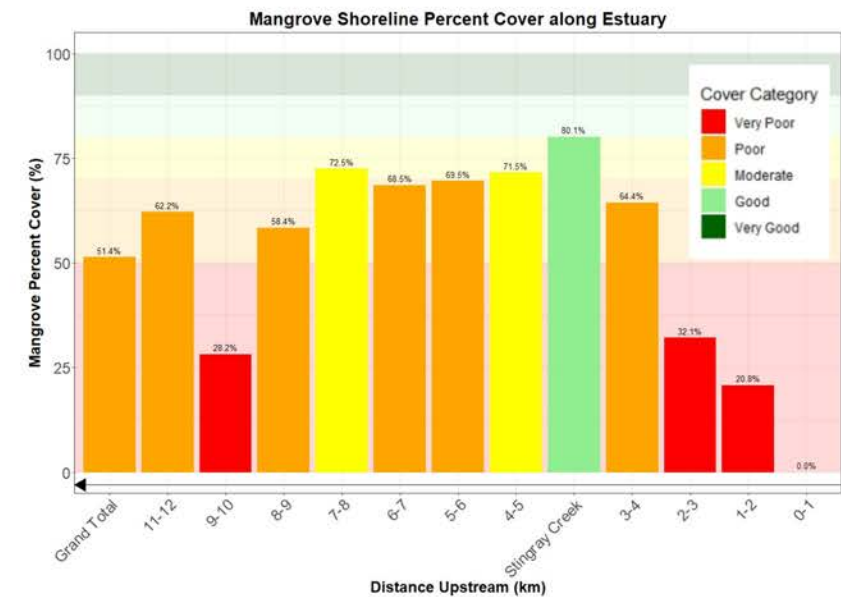
Mangrove cover along the lower Camden Haven River estuary is 'Moderate' compared to other surveyed estuaries. There are no mangroves present in the lower 1km of the estuary at the mouth with very low cover 3km upstream of the estuary mouth. Shoreline mangrove cover is highest at the confluence of the Camden Haven River and Stingray Creek. Extensive shoreline modification throughout the estuary, combined with increased estuary flow rates associated with hydrodynamic modification reduces mangrove establishment potential.

The absence of mangroves in the lower estuary limits natural climate risk mitigation, natural water quality improvement, fish habitat complexity and biodiversity refugia provided by shoreline mangroves. With increasing sea level rise and coastal hazard risks associated with climate change it is important that shoreline mangrove cover is improved in the lower estuary. To improve shoreline mangrove cover and associated ecosystem service values, it will be necessary to adopt ecological engineering approaches, such as living shoreline construction.

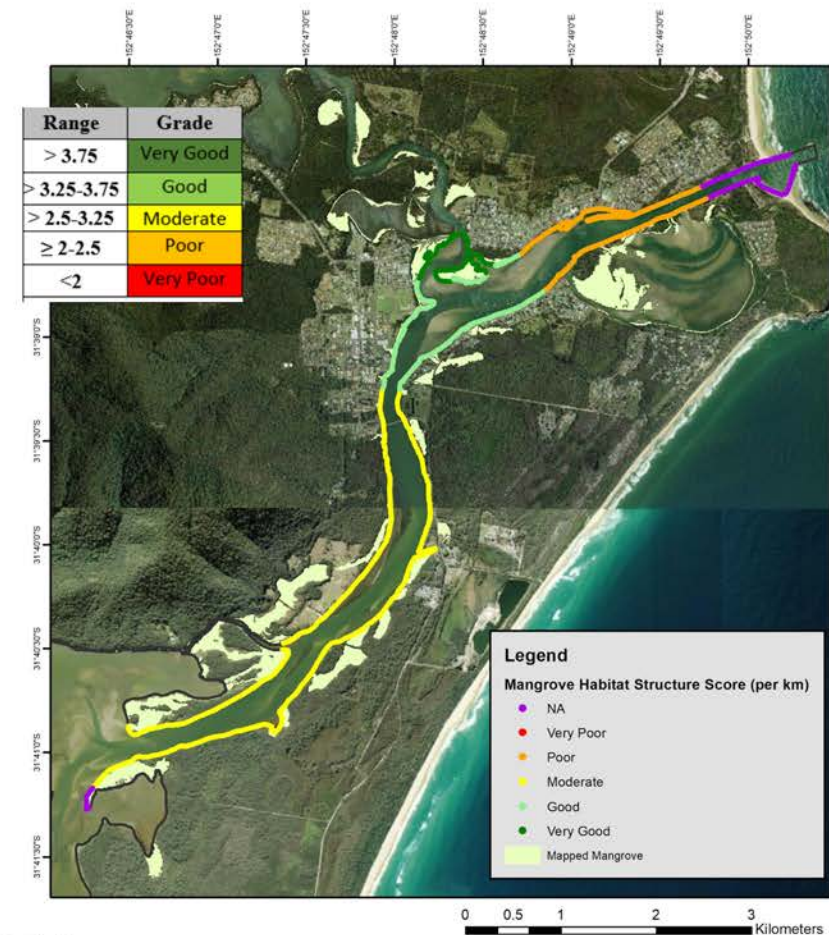
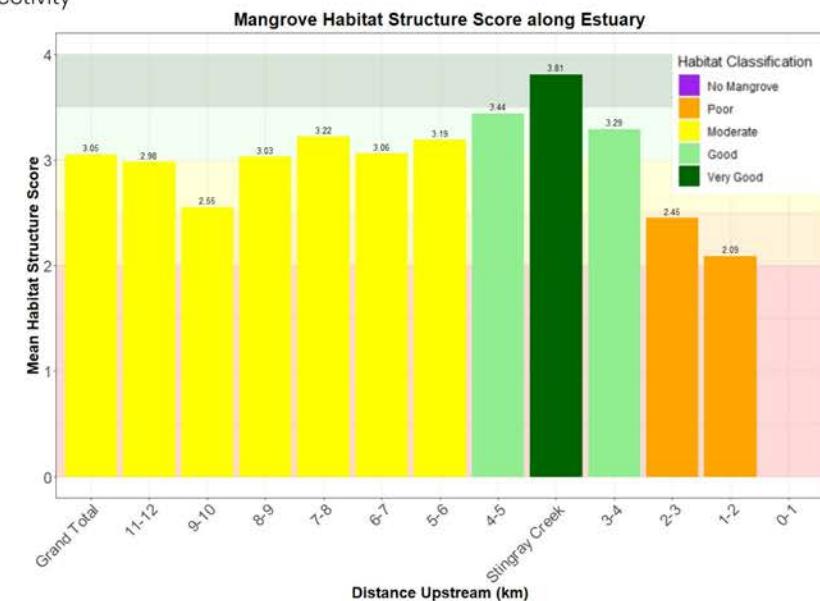
Shoreline mangrove forest structure is highest in the mid-estuary and lower Stingray Creek. These mangroves have high density, high connectivity and high stand maturity. These structural attributes relate to multiple mangrove ecosystem services including carbon storage, fish and wildlife habitat, coastal hazard risk reduction and water quality improvement. The lower estuary was scored 'Poor' for mangrove forest structure, with many shoreline mangrove stands disconnected from the main estuary channel. Efforts to conserve mangrove forest structure in the mid estuary and improve connectivity in the lower estuary will assist to protect and improve local estuary values.

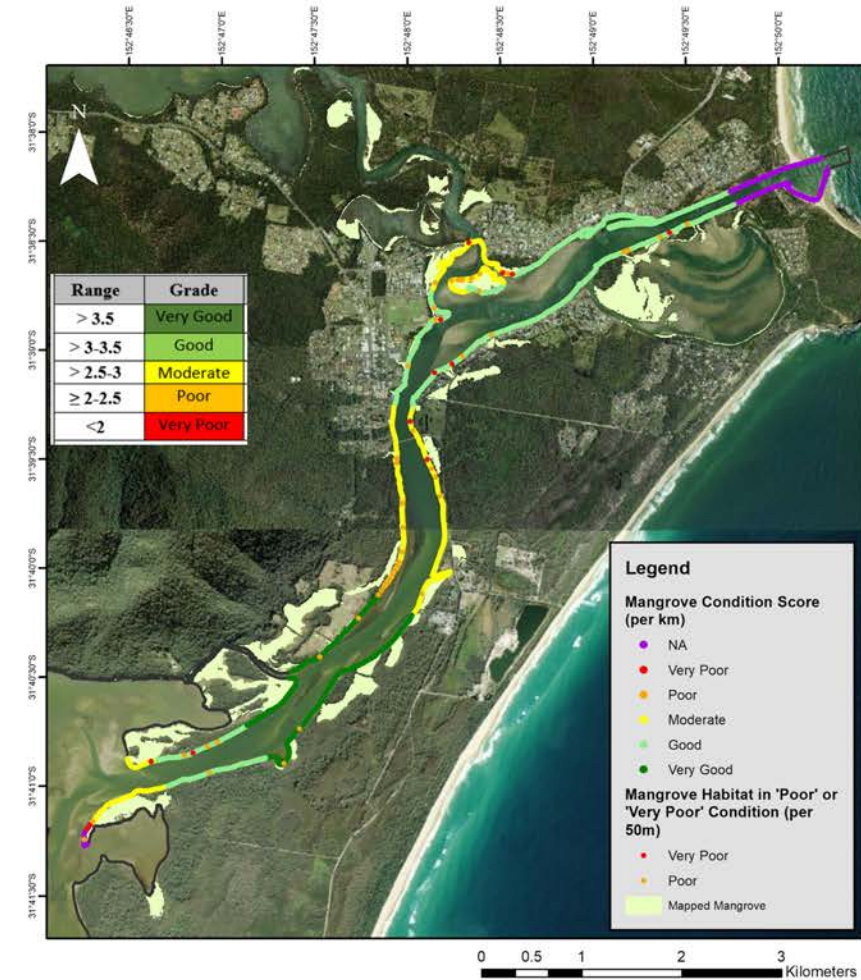
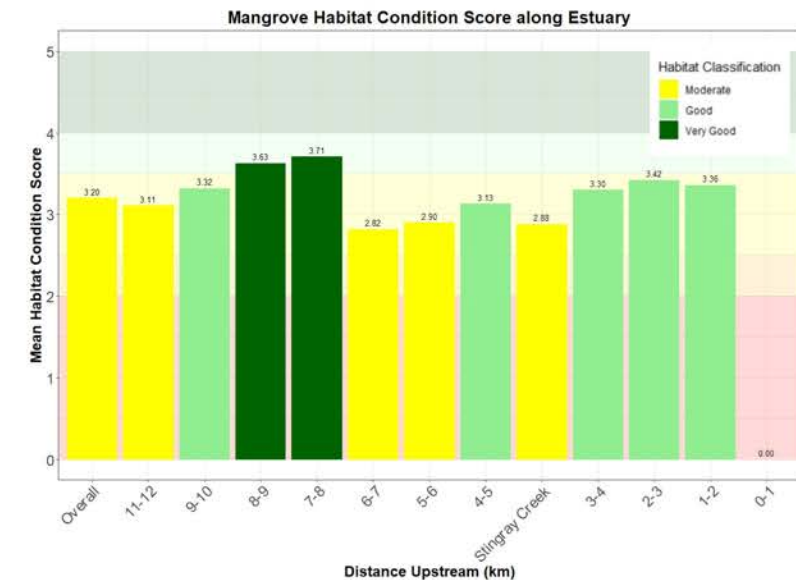
Mangrove condition along the Camden Haven River estuary is moderate, indicating that the majority of mangrove stands have minor dieback present, with many stands experiencing more severe dieback. Healthy mangrove stands (score 4-5) represent 42% of mangroves. An additional 35% had moderate dieback present. Mangrove stands in poor or very poor condition represented 22% of mangroves assessed, equivalent to 3.2km of mangrove shoreline. The relatively high proportion of poor condition mangroves suggests the presence of an ongoing or recent stressor impacting mangroves. Mangroves in the estuary were impacted by the 2019 bushfires, although this impact was largely restricted to the upper estuary in Watsons-Taylor Lake indicated by the moderate mangrove condition score for 11-12 km upstream. Based on this assessment, mangroves in the upper-mid estuary (5-7km upstream) and at the confluence of Stingray Creek had the lowest mangrove condition scores. Field inspection at the time of surveys show the cause of mangrove dieback and mortality in these estuary sections is linked to the 2021 flood event. This impact is described in more detail in the following report card section.

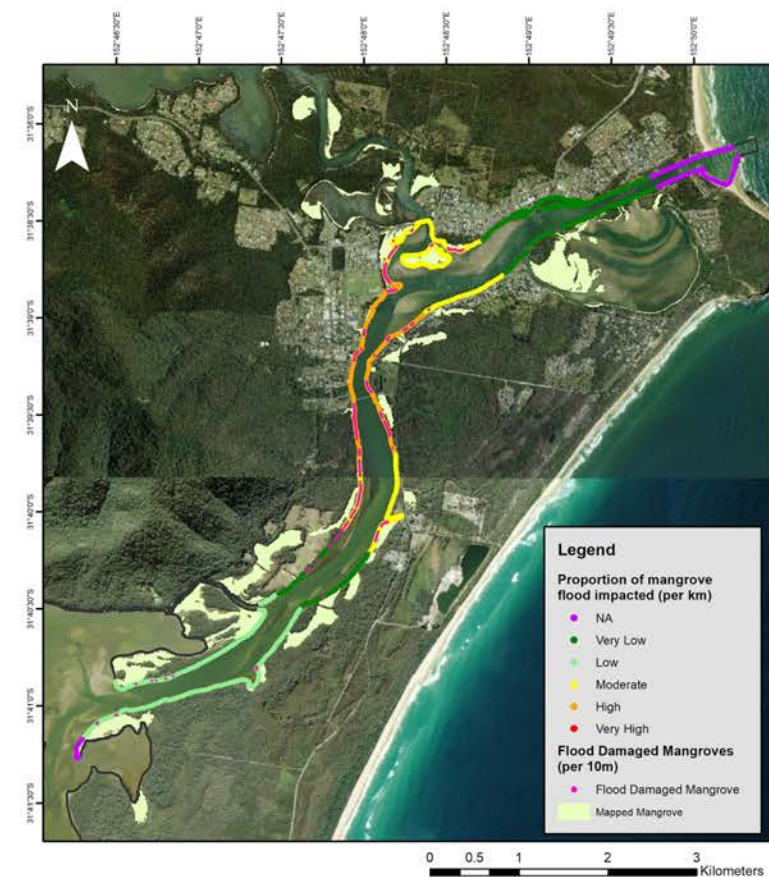
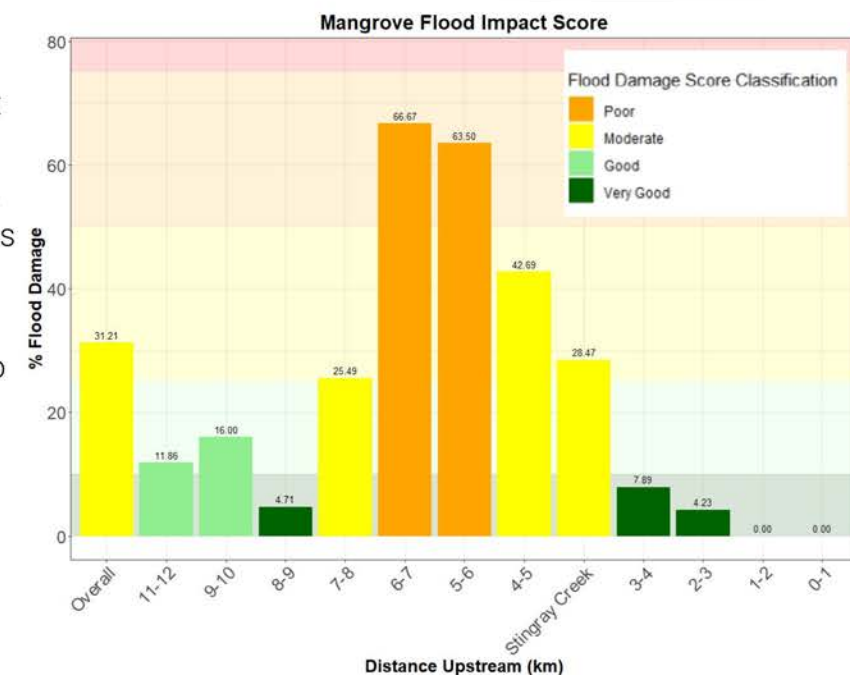
Recent severe flooding in NSW and Qld has significantly impacted fringing mangrove habitats. The Camden Haven River estuary experienced record flooding towards the end of March, 2021. The combination of the physical force of floodwaters, extended inundation period, sediment deposition on breathing roots, sediment erosion, impacts of prolonged freshwater on mangrove fauna and potential chemical pollutant deposition can result in extensive mangrove mortality. Often the effects of severe flooding do not become apparent until 6-12 months after flooding. Whilst mangroves can recover from flood events, full recovery from severe impacts can take 10-30 years. During the recovery period mangroves are vulnerable to additional climate and human pressures. Increasing sea levels often results in fringing mangrove setback leading to a nett loss of shoreline habitat. Within the Camden Haven River estuary, 31% of mangroves were severely impacted by flooding, with the most extensive impact in the mid-estuary. The primary driver of flood-related impacts appears to be sediment root burial. However, elevated nutrient loads may also increase flood impact risk.

This flood event highlights the vulnerability of shoreline mangroves to climate stressors. Given the recovery trajectory and likely loss of mangrove habitat, additional efforts to enhance and protect unimpacted mangroves should be considered.

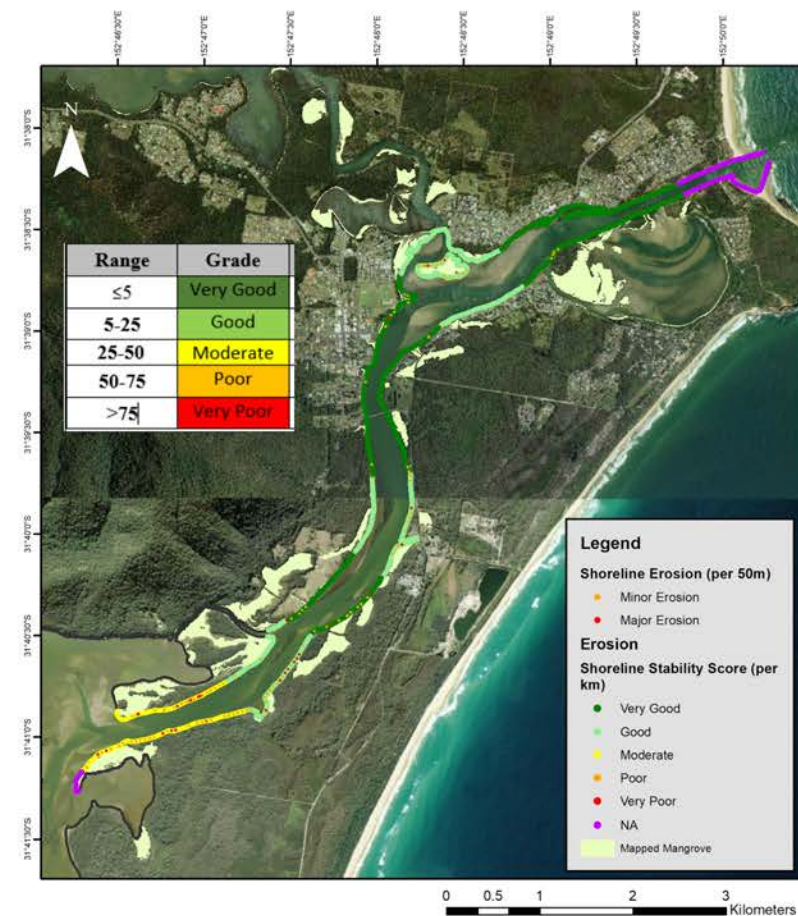
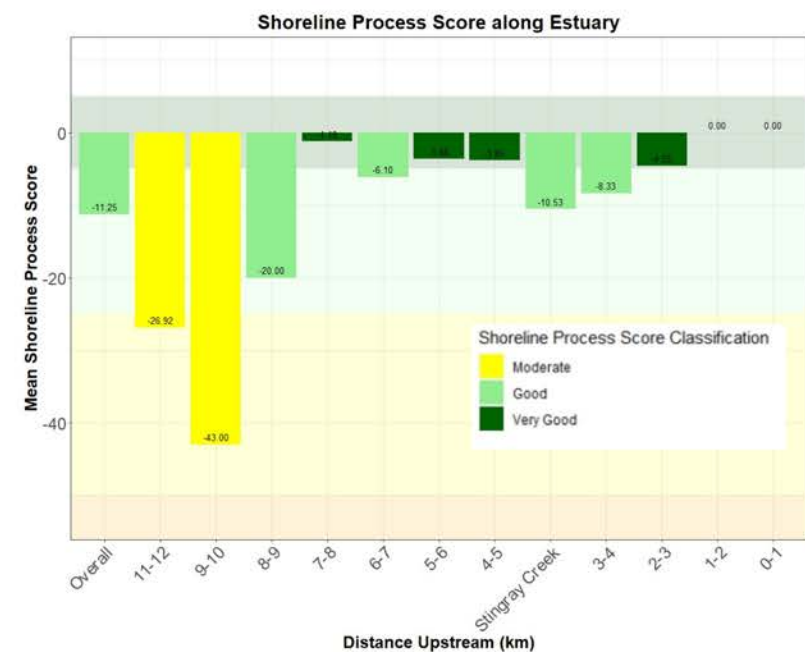
Erosion is the dominant shoreline physical process in the Camden Haven River estuary with 28% of the shoreline in an exposed and retreating state, however only 6% of erosion was classified as severe. Most erosion was recorded in the upper estuary. The extensive shoreline armoring along the lower estuary prevents natural shoreline dynamics that would normally be observed. The only erosion area of concern is an island at the confluence of Stingray Creek where high value habitat with very old Grey Mangroves (*Avicennia marina*) is at risk of loss from shoreline retreat.

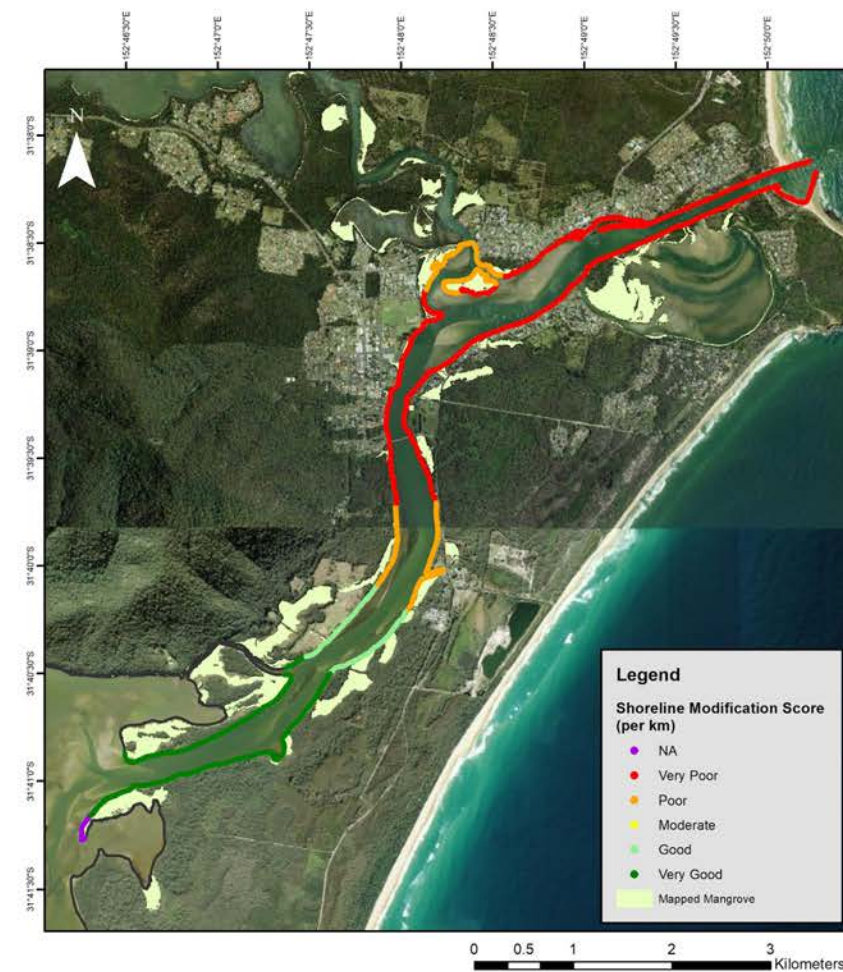
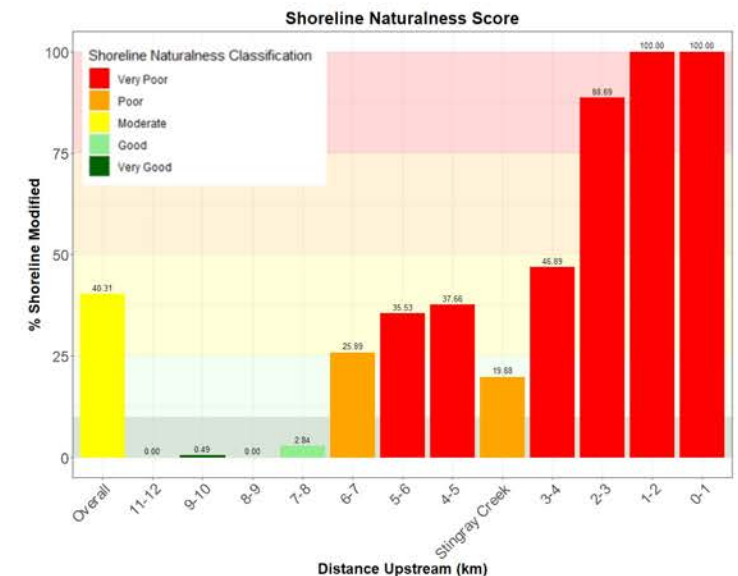
The majority of shoreline in the lower Camden Have River estuary is modified with rockwall and rip-rap structures. These modifications have substantially altered estuary hydrodynamics and increased tidal flow velocity in the lower estuary. High flow velocity limits mangrove rockwall colonisation and establishment potential. Consequently, there is low fish habitat diversity along the lower estuary main channel. In the mid estuary, mangroves are more frequently observed seaward of rock wall structures, highlighting the potential to integrate additional green-grey shoreline modification approaches within the estuary. Historically, bank hardening was not designed with mangrove habitat in mind. However, these existing structures can be modified to enhance mangrove colonisation to maximise both shoreline protection and stabilisation and habitat-related values including climate change risk reduction using a 'living shoreline' approach.

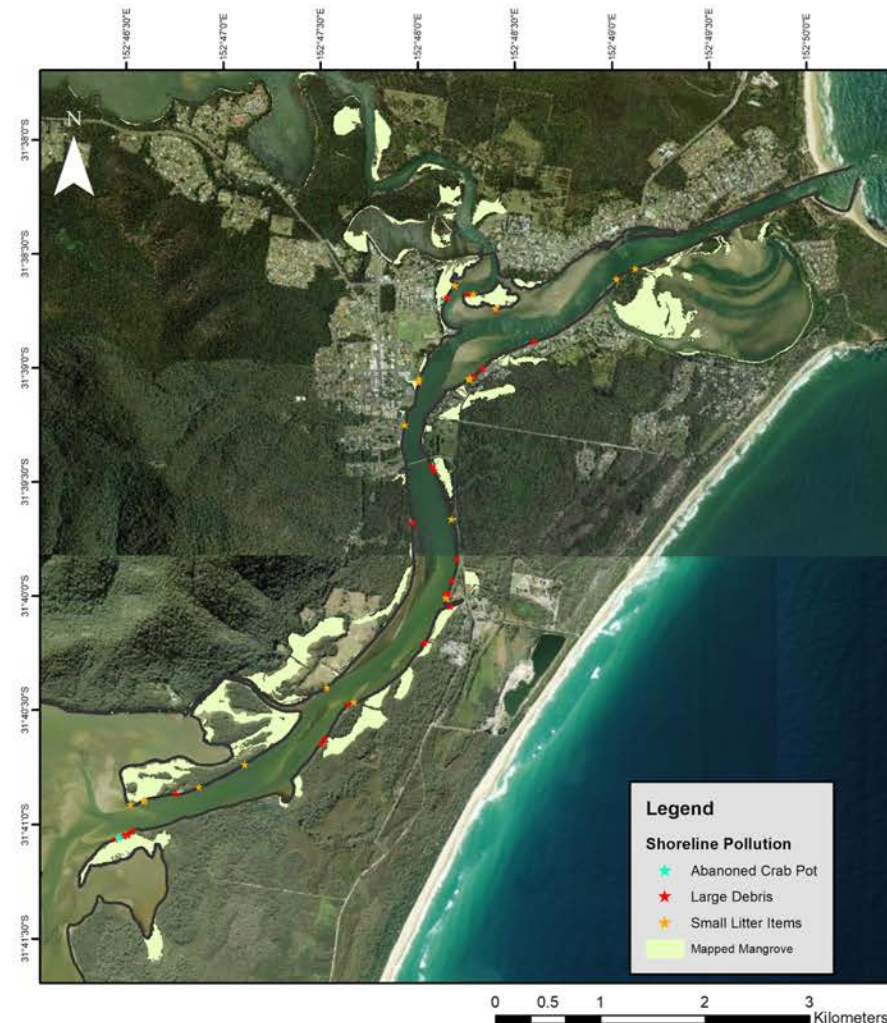
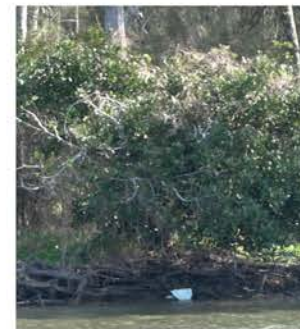
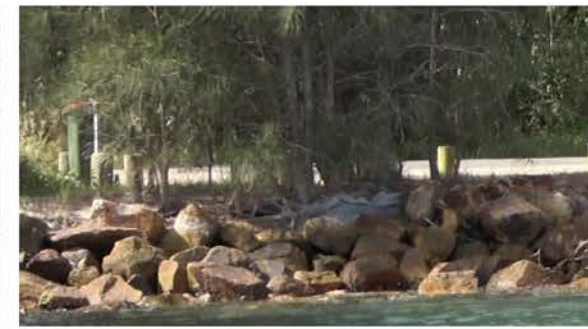
There were 49 items of marine debris along the surveyed shoreline, equivalent to 2.33 items per km of shorelines. Small litter items were mostly soft plastic packaging. Larger debris items were blue storage barrels associated with the oyster industry, other larger plastic items and dumped building rubble used for shoreline stabilisation. The breakdown of these items can lead to microplastic pollution and additional toxins entering the marine environment and marine food chain. Exposed geofabric along some rockwall sections. This material has been shown to be a significant source of microplastics. Plastic in the mangrove environment is likely to impact crabs and other mangrove macrobenthic fauna important for ecosystem health.

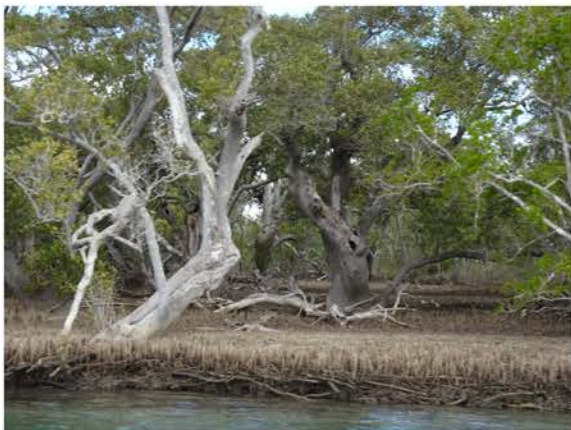
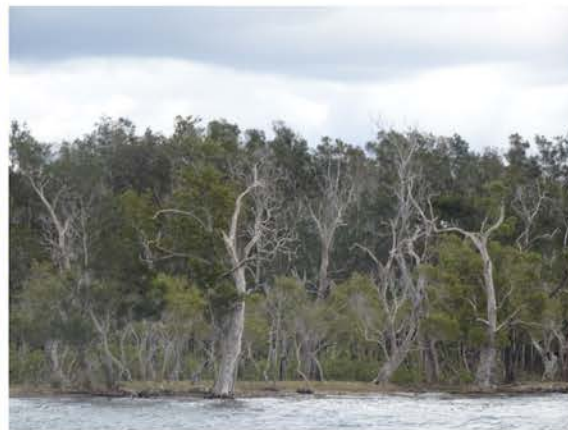
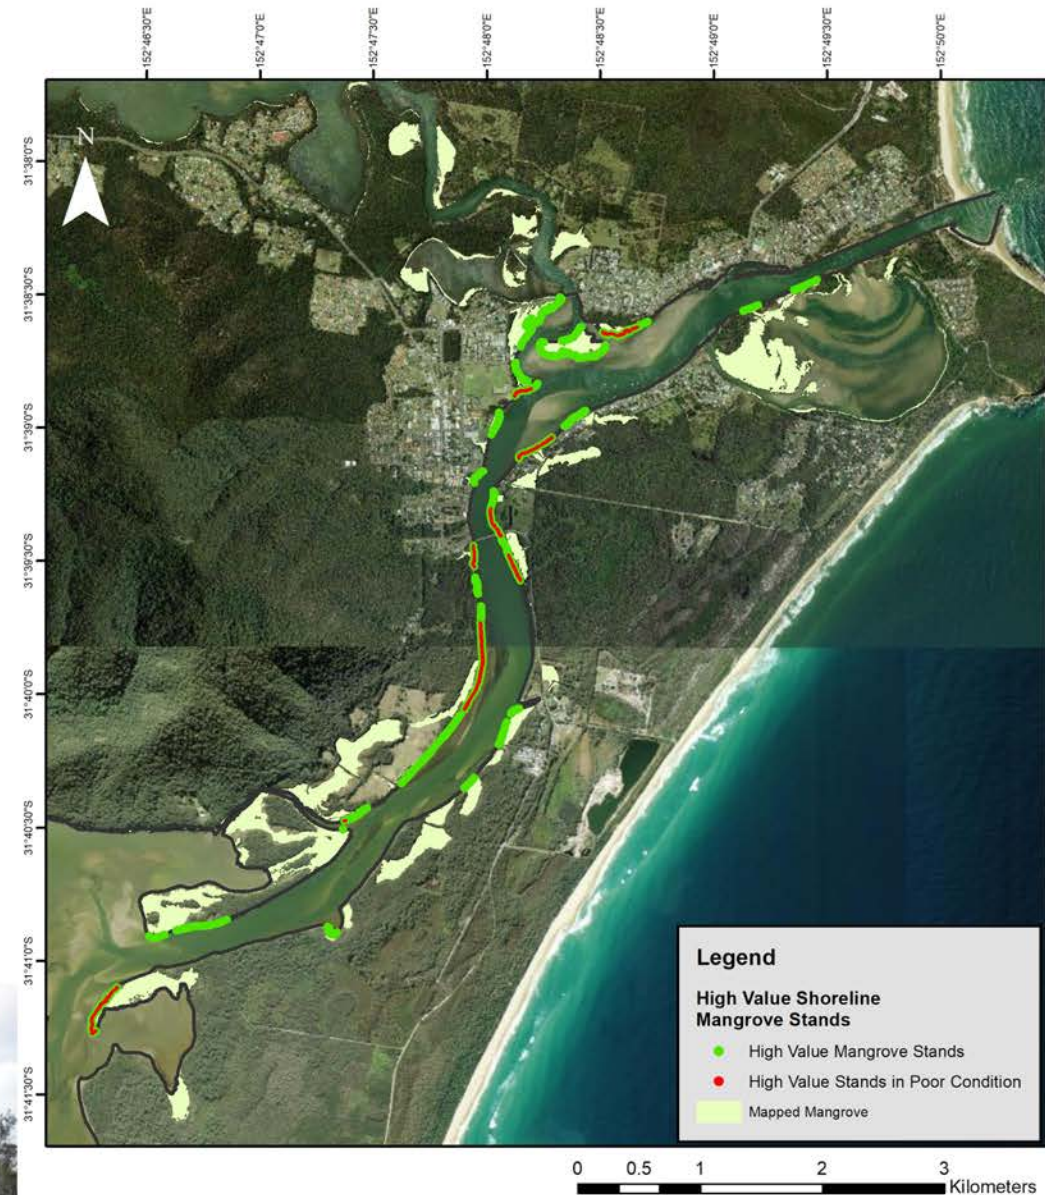
High-value mangrove stands were identified in the lower Camden Haven River estuary using a combination of standardised and normalised habitat continuity and habitat structure scores. The identified high-value mangrove stands have extensive continuous shoreline cover and high habitat structural value linked to mangrove ecosystem service provision. The majority of these high-value stands are present in the mid and upper mid-estuary. Some of these stands were severely impacted by the 2021 floods, placing these important estuary habitats at risk. To assist the prioritisation of future management actions and investment in the estuary, these at-risk high-value estuary patches are shown on the adjacent map. Activities that seek to enhance habitat recovery or reduce additional ecosystem risks to these mangrove stands should be prioritised. Such activities may include, litter and debris removal, feral animal control, reducing pollutant and nutrient loads and minimising boat wake. Active climate adaptation enhancement measures such as facilitate planting combined with engineering approaches to prevent habitat loss should also be considered.

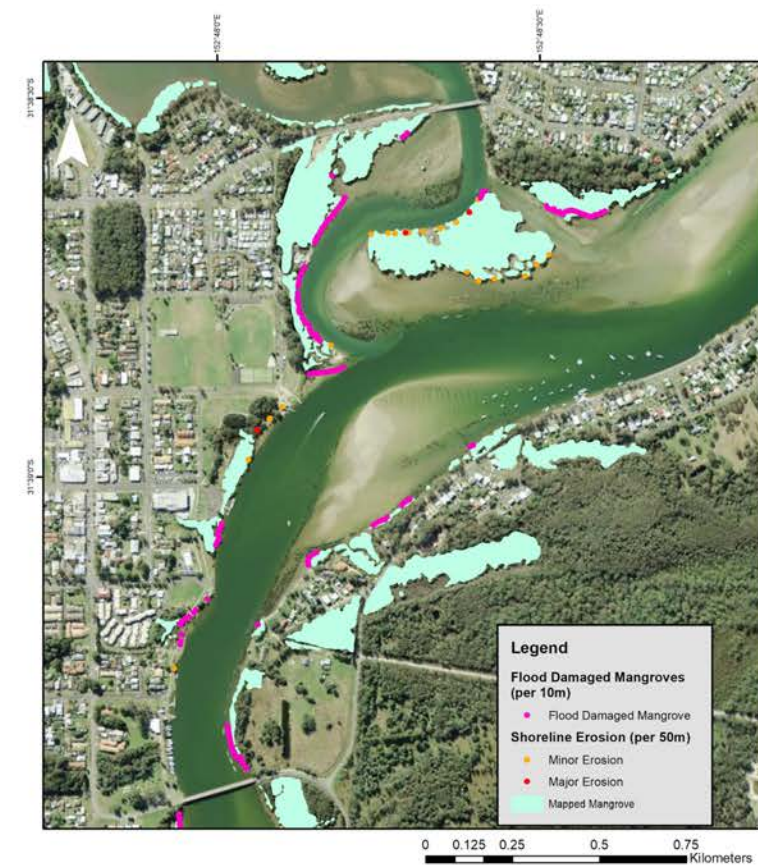
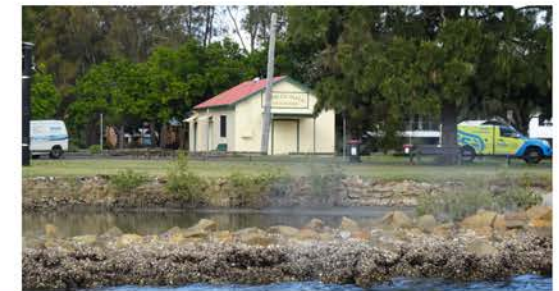
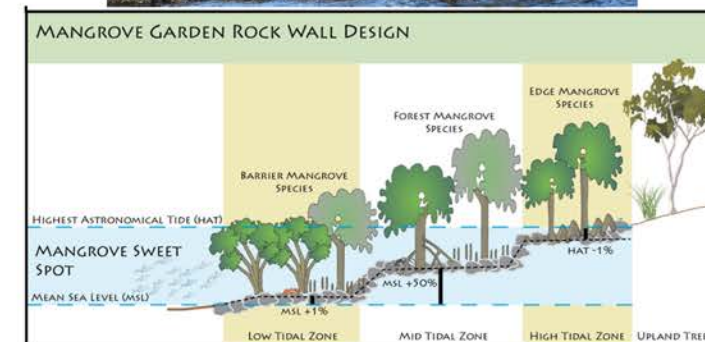
Mangroves in the mid-estuary near the confluence of Stingray Creek were severely impacted by the 2021 flood event and resulting sediment root burial and shoreline erosion. There is risk of significant and high-value habitat loss in the near future without intervention. Compounding climate change pressures increase the need for implementing active climate adaptation measures to protect mangrove habitat to ensure the long-term protection of estuary ecosystem values and reduce coastal hazard risks. These measures will require integrated engineering approaches. The business-as-usual conservation approach to estuary management is no longer appropriate. During S-VAM surveys it was observed that historically dumped oyster shells provided a living breakwater that protected adjacent mangroves from flood events. Similar observations have been made elsewhere. The opportunity to install additional living breakwaters using oyster shell as a means to protect mangrove habitat should be investigated. Living breakwater structures could be complimented by the construction of 'mangrove garden' living shorelines to assist in offsetting any additional habitat loss in the mid-estuary.
