CLYDE RIVER ESTUARINE SHORELINE HABITAT CONDITION REPORT CARD 2023

Author: Jock Mackenzie
Earthwatch Institute

Survey Date: 10th August 2023.

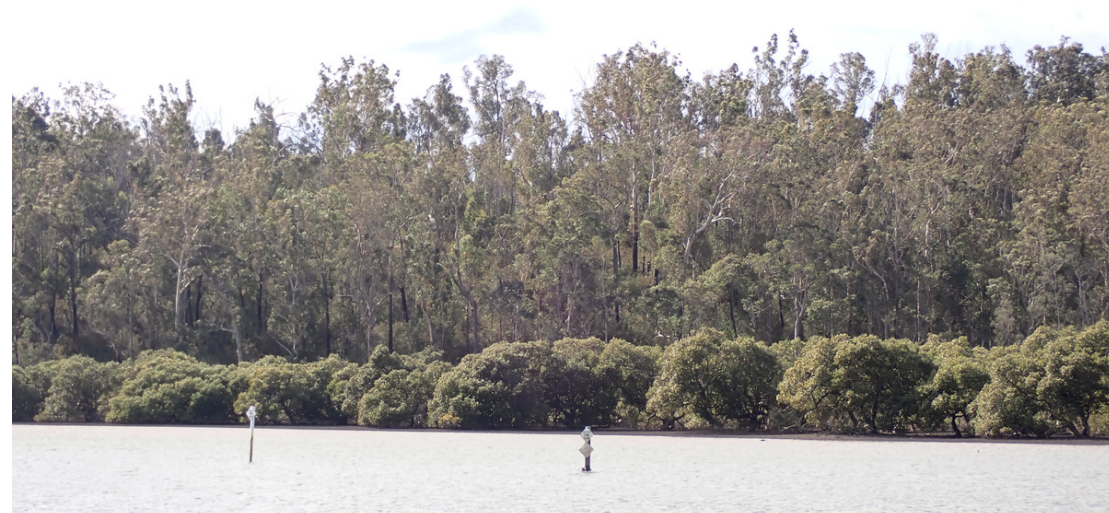
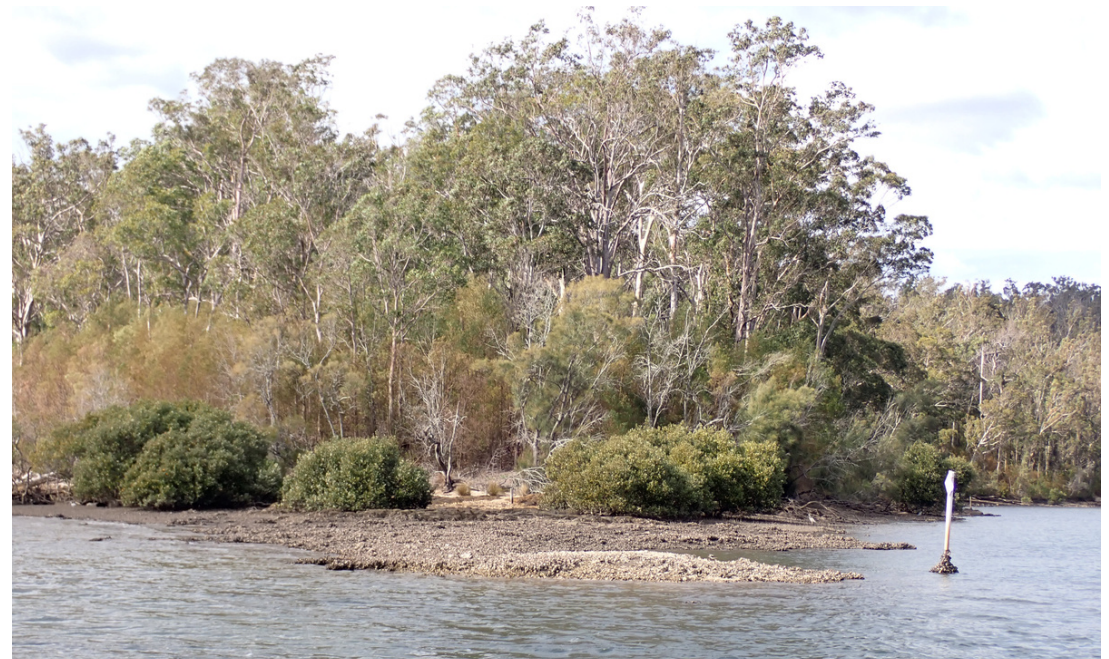
Overall Shoreline Mangrove Cover = 70.1%

Overall Mangrove Cover Score = **Moderate**

Mangrove cover along the lower Clyde River estuary is 'Moderate' compared to other surveyed estuaries with 70% cover. Mangrove cover was lowest (49%) in the upper reaches of the estuary surveyed (7-9 km) and near the estuary mouth (59%, 2-3km). Throughout the estuary, mangrove establishment is limited by steep rocky shorelines. Towards the mouth of the estuary, shoreline modification limits mangrove development. Despite the 'moderate' shoreline mangrove cover, mangroves are consistently present along the shoreline as narrow stands, isolated patches and dense mature stands in protected embayments.

Hard wall structures in the lower estuary are suitable for habitat enhancement using living shoreline approaches to enhance mangrove cover in the lower estuary and provide additional ecosystem service benefits including fisheries production and water quality moderation.

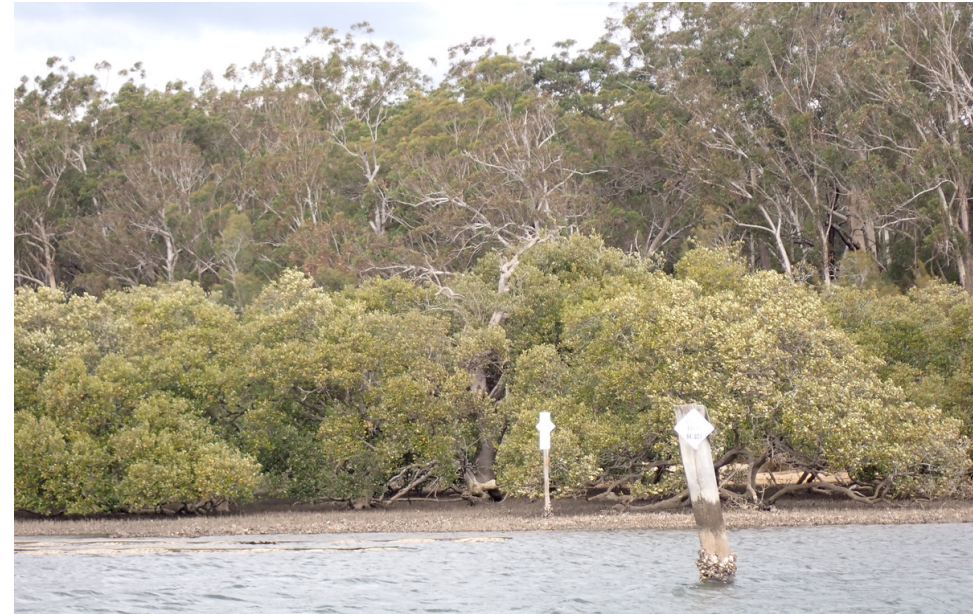
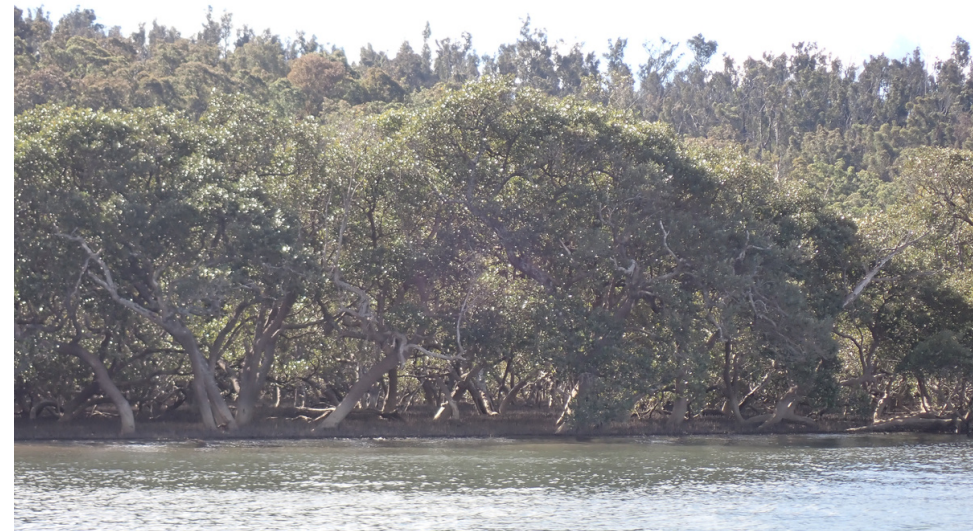
Shoreline Mangrove Habitat Structure

Mean Habitat Structure Score = 3.1

Overall shoreline mangrove forest structure in the Clyde River estuary is 'moderate', but also highly variable with narrow open fringing mangroves along rocky shorelines interspersed with dense, old growth mangrove forest in protected embayments. Mangrove forest structure is highest in the lower-mid estuary (4-6km upstream), including Pelican Inlet. 51% of mangroves in this section of the estuary were classified as 'old growth' mature stands with high habitat value. Overall, 79% of shoreline mangroves were classified as either mature (44%) or 'old growth' (35%). This high-level of mature mangrove stand development is indicative of a historically relative stable estuary, free from natural and human disturbance. Mature mangrove stands have high biodiversity and carbon storage values. These mangroves therefore have high conservation significance and should be considered an important feature of the marine park and marine estate.

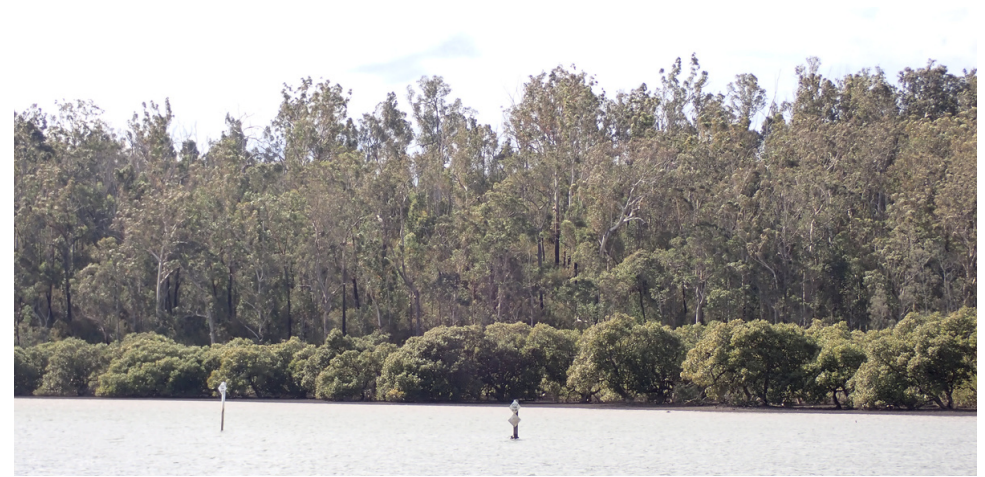
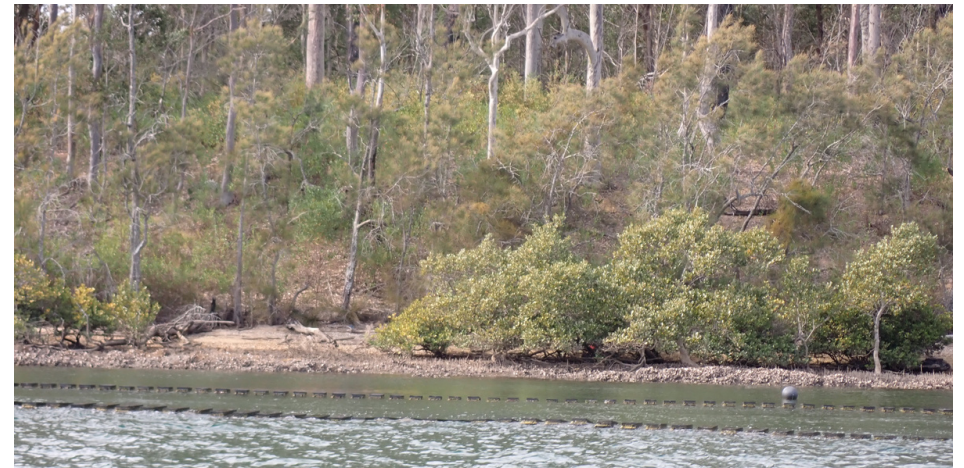
Shoreline Mangrove Continuity

Overall Habitat Continuity Score = 0.35

Habitat patch size is directly linked to habitat values, particularly biodiversity, water quality moderation and fisheries values. Reduced patch size increases estuarine shoreline habitat vulnerability to flooding and erosion, and increases the risk of damage to shoreline infrastructure. Mangrove habitat continuity along the Clyde River estuary is classed as moderate. Many non-contiguous mangrove stands (<40m) were observed along steep rocky shorelines interspersed with contiguous mangrove stands in protected embayments. Contiguous mangroves are present along much of the lower-mid estuary shoreline, 2-3km upstream, with 75% continuous mangrove habitat. Habitat continuity is low (8%) in the upper-mid estuary (8-9km upstream) and in lower Waterfall Creek.

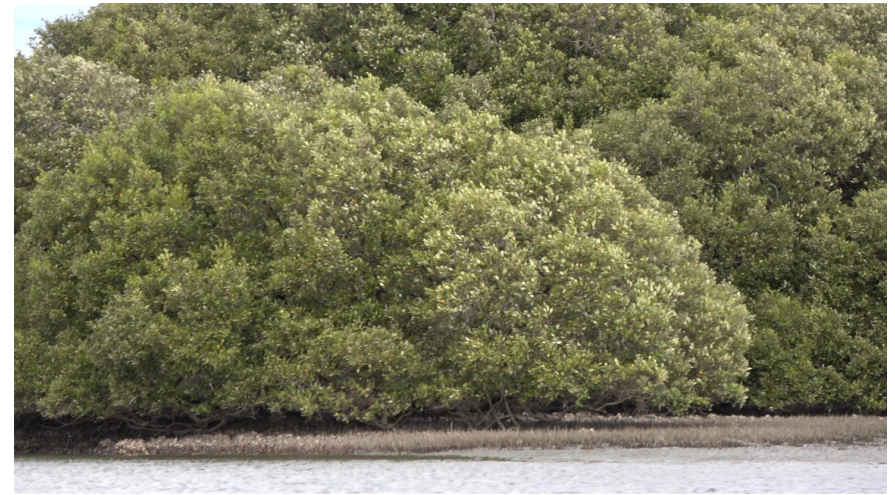
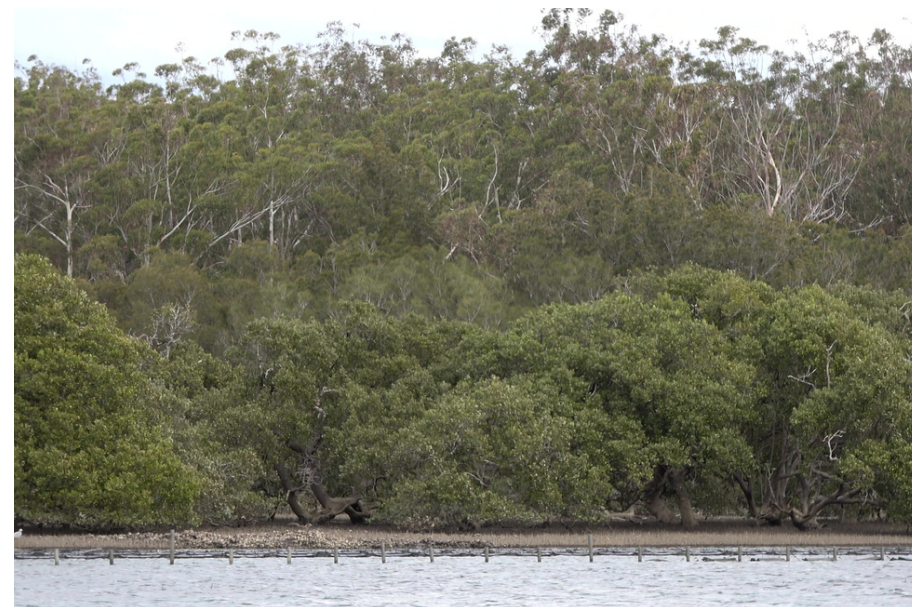
Shoreline Mangrove Condition in mangroves not impacted by fire

Mean Unimpacted Habitat Condition Score = 3.3

Unimpacted Habitat Condition Grade = Good

Mangroves not impacted by fire in the Clyde River estuary are mostly healthy to very healthy. Very little dieback or tree mortality in shoreline mangroves was observed in unimpacted mangrove stands. *Avicennia marina* (Grey Mangrove) often show low-level dieback in relation to changing climate conditions, sea level variations, natural disturbance events, pollution and estuary modification. The high proportion of healthy mangroves with no or <10% estimated canopy loss suggests mangroves in the Clyde River estuary are highly productive and relatively free from disturbance and stressors outside of the fire impact. This observation corresponds with the well-developed mature stands within the estuary. This data highlights the significance of the 2020 bushfire impact on an otherwise healthy mangrove system, and demonstrates that even healthy, well-protected mangroves are vulnerable to climate change-related disturbance events.

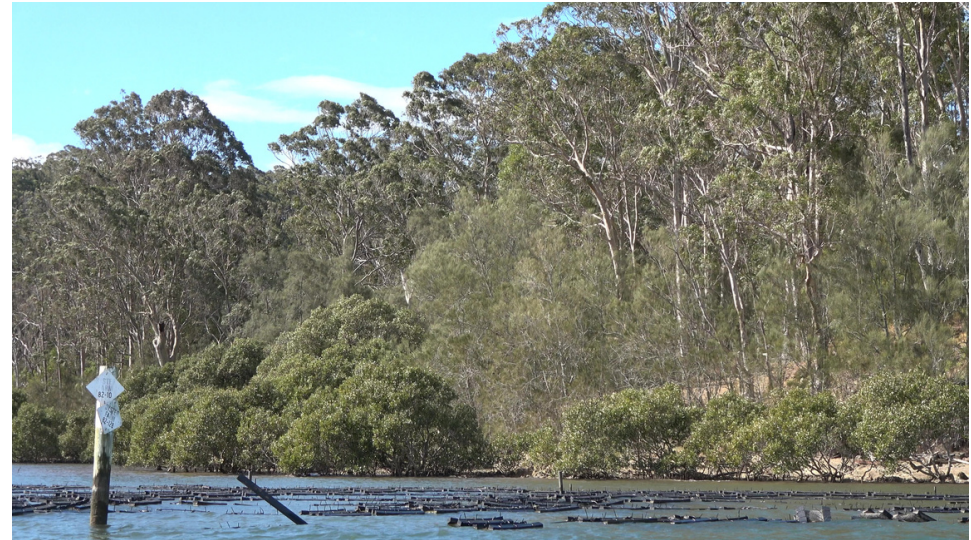
Shoreline Physical Process

Overall Shoreline Process Grade = **Very Good**

Proportion of shoreline eroded = 0.9% (~150 m)

The Clyde River estuary shoreline is stable with very little erosion or deposition recorded. Low levels of physical and hydrodynamic processes have likely contributed to the presence of healthy, well-developed mangrove stands in the estuary.

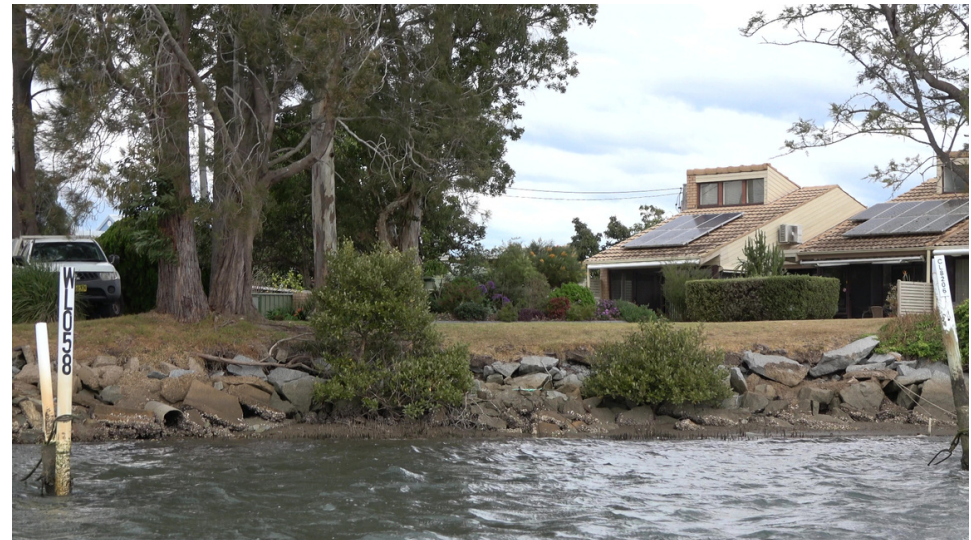
Overall Shoreline Naturalness score = 5.4

Only 3.8% (630m) of shoreline is modified in the lower Clyde River estuary. Most shoreline modification occurs towards the estuary mouth. Existing rock wall structures have high 'living shoreline' enhancement potential.

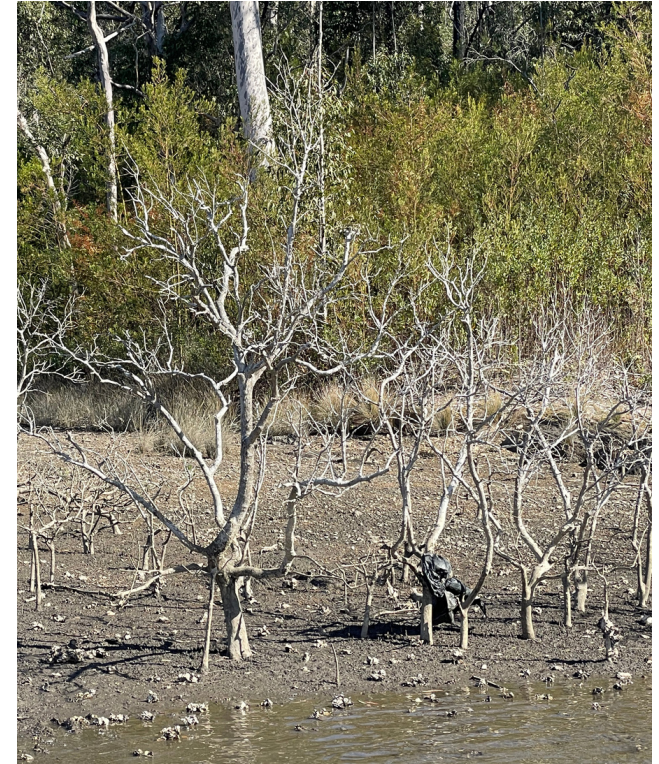
Shoreline Marine Debris

Total items observed = 14
(0.83 items per km)

Small litter = 9, Large Debris = 5,
Abandoned Crab Pots = 0

Minimal litter and marine debris was observed in the estuary along the shoreline. Field observations indicate the majority of litter and debris in the estuary originates from oyster industry activities, such as mesh, floats and rack material.

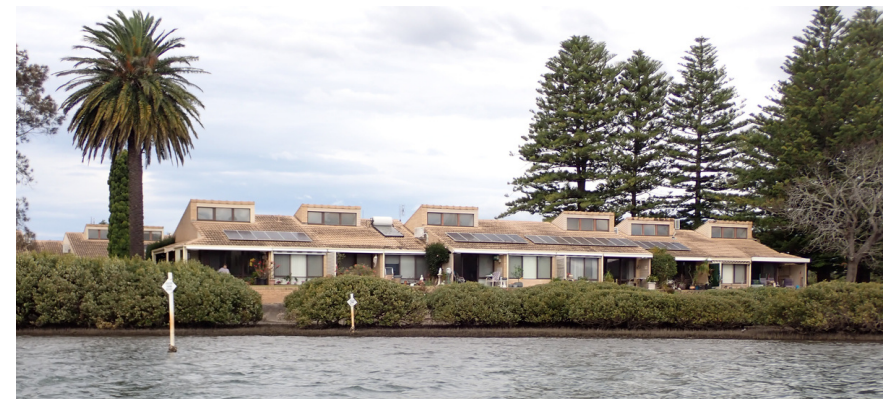
Other human disturbance

Trimmed mangroves = 100m

A small section of trimmed mangroves for view maintenance is present at the confluence of McLeods Creek. It is unlikely that this trimming has significant impact on mangrove habitat values or resilience. However, this activity should not be encouraged elsewhere and may reflect poor local attitudes to mangrove habitats.
