## Stormwater controls – Sydney

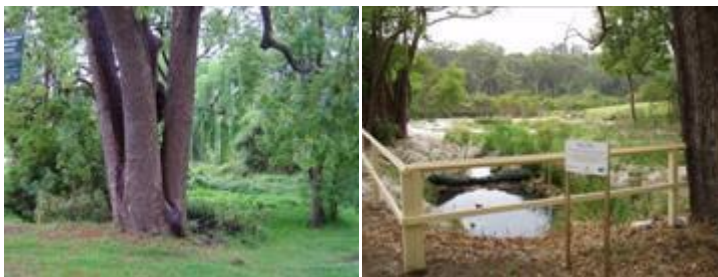
*Before and after photo from the top of the creek. Exotic weeds choking the creek have been replaced with natives and the channel is once again visible. Another grant has been sourced recently by council to extend the works towards the mangroves*

**Outcome:** This project minimised the amount of material covering the mangrove roots by working upstream at the source of the pollution input. Channel realignment and replanting with native species was coupled with stormwater retention devices designed to remove contaminants before entering the creek.
